## Report on the Initial Testing of Suspect Tiger Tail Comets

K. L. and B. J. Kosanke

It was previously reported that two out of forty 5-inch White Tiger Tail comet shells had explosively malfunctioned upon firing, destroying their mortars and the racks that contained them. While traveling to conduct display safety training, it was arranged to visit the display company that experienced the problem with the comet shells. During that visit, the damaged mortars were inspected, photographed and sampled for pyrotechnic residues; the problem shells and some similar items were dissected, their components weighed and photographed; and fifty of the comet shells were test fired while being video taped. This article reports on that work.

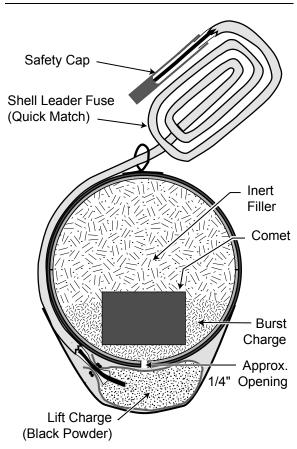
Figure 2. An illustration of the style of construction used for the "Tiger Tail" comet shells.

Normally (traditionally) tiger tails are made by forming a thick layer of comet composition on the outside of an aerial shell, which is then covered with a single loose wrap of paper. The purpose of this type construction is to produce a comet with a much greater burning surface (i.e., one producing a much more dense trail of sparks) than would be possible by simply attaching one or more comets to the outside of a shell. To that extent the so called "Tiger Tail" comets suspected of producing the powerful in-mortar explosions are not really tiger tail comets in the normal sense. To determine the manner of construction of some other tiger tail comets in stock at the
